## Space Needs Analysis Bristol Municipal Buildings

### **Bristol City Hall**

**Mechanical and Electrical Systems**  
**Existing Conditions Narrative**

**City Hall**  
**Bristol, Connecticut**  
November 1, 2011

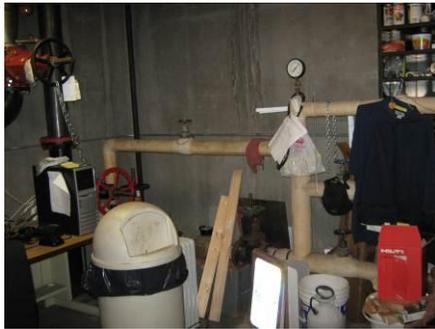
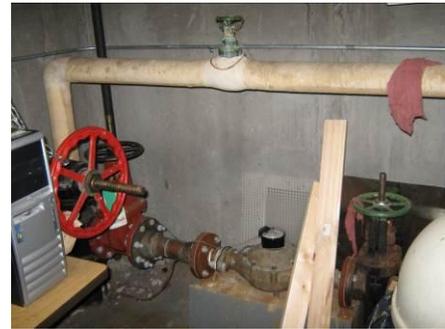
- a. Existing Domestic Water Service: The existing building is currently served by a 4 inch domestic water service. The domestic water service equipment includes a 2 inch water meter, pressure reducing valve, and isolation valves. This water service currently serves all of the building's domestic water needs and has adequate pressure. The water distribution system is original to the building.

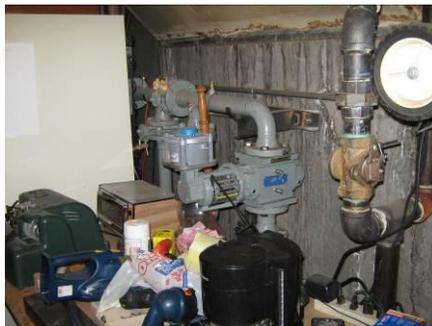
- a. Existing Natural Gas Service: The natural gas service enters the front of the building from a main gas line on North Main Street. The gas service is located in the basement adjacent to the fire and domestic water services. The service entrance equipment includes a remote metering assembly and shut-off valves.

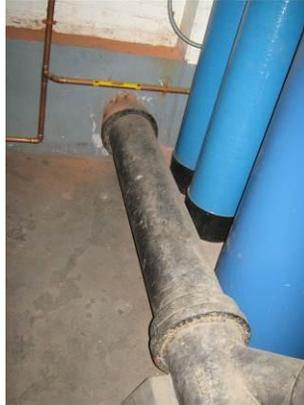
- a. Existing Sanitary Service: The sanitary sewer system provides sanitary waste drainage for plumbing fixtures located throughout the building. The piping material above grade is primarily cast iron. The plumbing fixtures drain to buried sanitary waste piping to the buildings exterior and to the municipal sewer system.

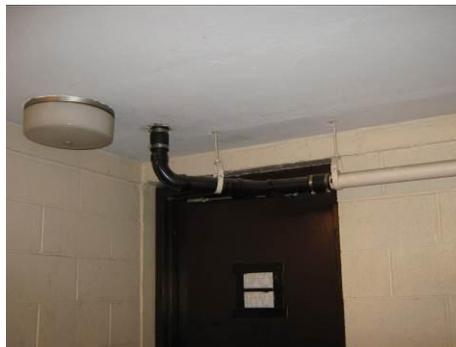
- a. The storm piping is primarily cast iron and drains to the municipal storm water system. There are no secondary roof drains.
- b. There are areas of the storm water system where the piping has been replaced with PVC. Further investigation should be done to determine the exact cause of the failure.

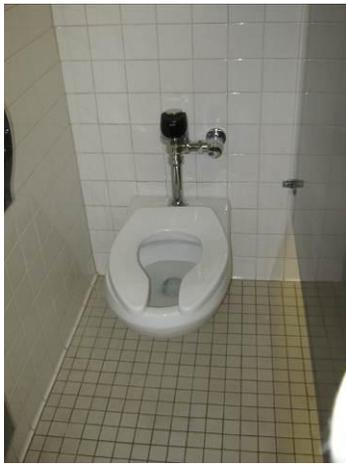
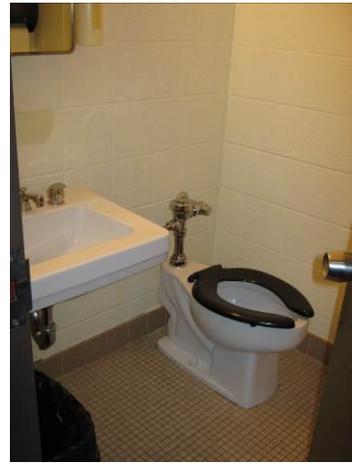
- Water closets are floor or wall mounted; flush valve, vitreous china. Some of the fixtures have been replaced with water conserving fixtures with sensor operated flush valves. The fixtures range from original to the facility in fair condition to new in very good condition. The original fixtures are non-water conserving type and non-ADA compliant.

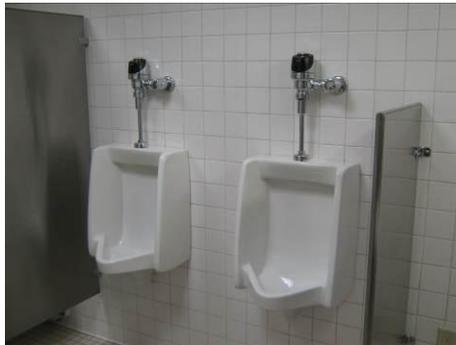
- Urinals are wall hung, vitreous china, with flush valves. Some of the fixtures have been replaced with water conserving fixtures with sensor operated flush valves. The fixtures range from original to the facility in fair condition to new in very good condition. The original fixtures are non-water conserving type and non-ADA compliant.

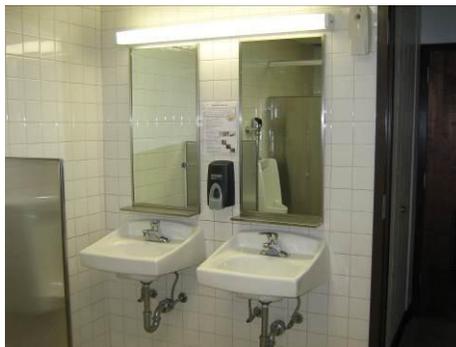
- Lavatories are wall hung vitreous china. Some of the fixtures have been replaced with water conserving fixtures with sensor operated faucets. The original fixtures are a combination of two lever handle or metered faucets. The fixtures range from original to the facility in fair condition to new in very good condition. The original fixtures are non-water conserving type and the faucets and drains are non-ADA compliant.

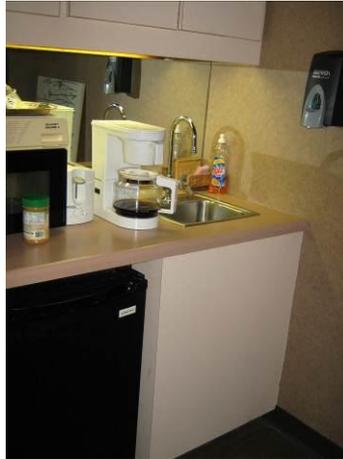
- Drinking fountains are wall mounted stainless steel units in good condition. The amount these units protrude into the path of travel should be reviewed for compliance with current ADA requirements.
- A Stainless steel sink with two lever gooseneck type faucet is present in the Mayor's office. This sink is non-ADA compliant and in good condition.

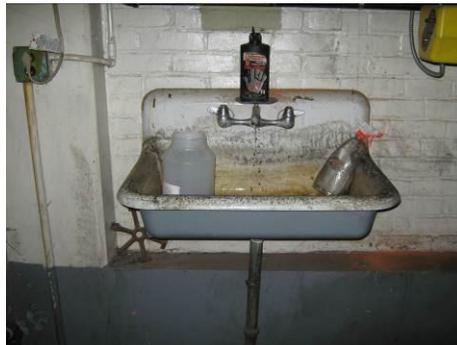
- Janitor sinks are wall mounted cast iron units with two lever faucets. There is no vacuum breaker present at these sinks. The sinks are original to the building and in poor condition.

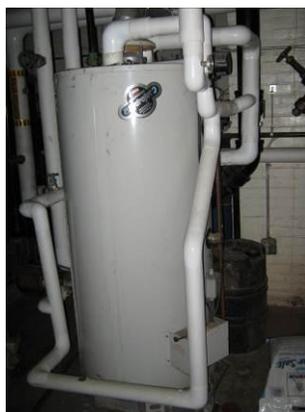
1. The existing domestic hot water system includes a Bradford White Model D75T1253N natural gas fired domestic water heater. This water heater has no gas supply or electrical power to it. It appears that this water heater is fed from the boiler system. This equipment is in poor condition.

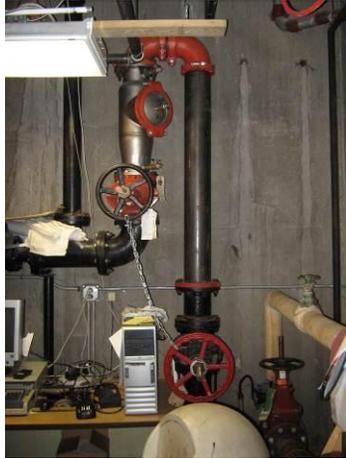
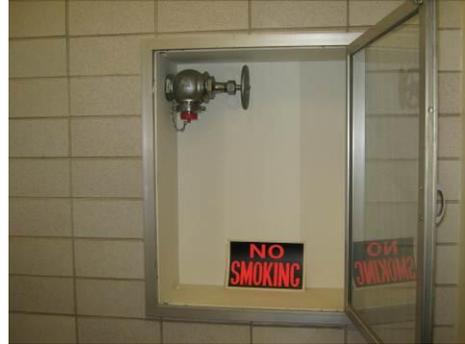
1. The building is served by a 6" fire protection service fed from a fire main in North Main Street. This fire service includes a shut-off valve and Watts Model 774 double check valve. This fire protection service feeds standpipes only located in the stairs. There are no sprinklers in the building. This fire service equipment has been recently installed and is in good condition.

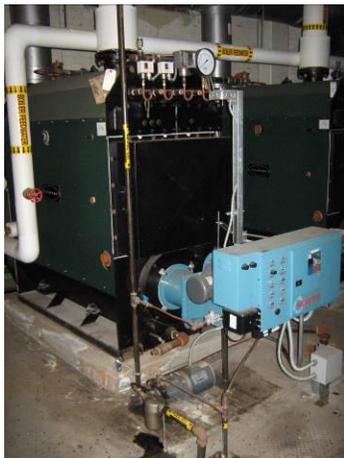
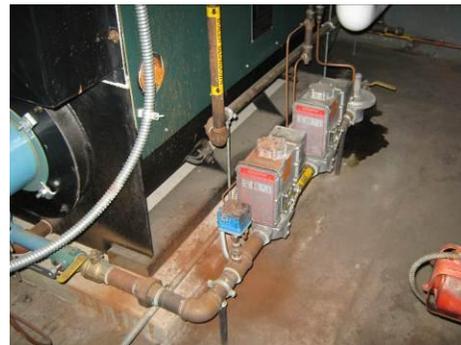
1. The existing building is heated by (2) Columbia Boiler Model MPH-60 steam boilers with Cyclonic Model JB2C-10-RM7800L-M.15-MP-UL-FM dual fuel burners. The burners do have gas train equipment installed, however, there is no gas piping to the burners. They operate on oil only at the present time. The boilers, burners, and breeching have been recently installed and all are in very good condition.

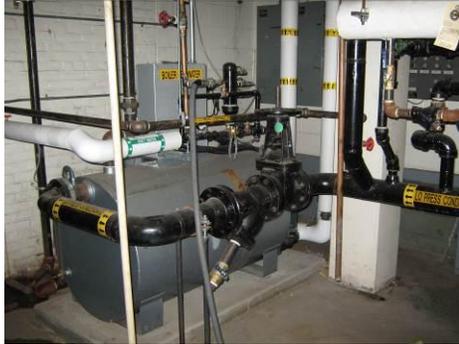
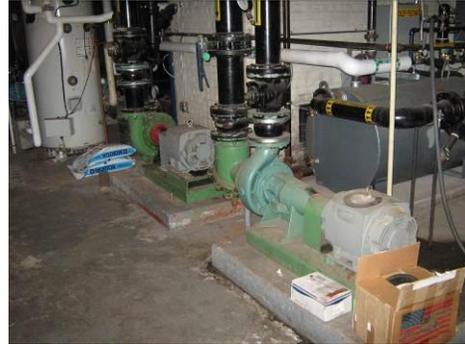
2. The heating plant also includes a new condensate receiver, boiler feed system, hot water heat exchanger, and hot water pumps. All of this equipment was installed with the boilers and is in very good condition.

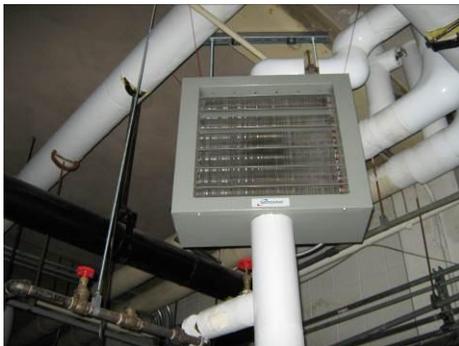
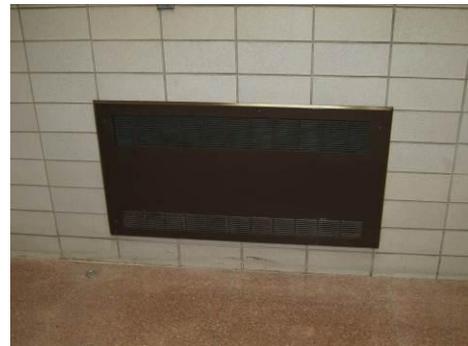
3. The present heating system also includes cabinet unit heaters, and ceiling mounted unit heaters and steam coils in the 4<sup>th</sup> floor air handling equipment. This equipment is original to the building and in good to very poor condition.

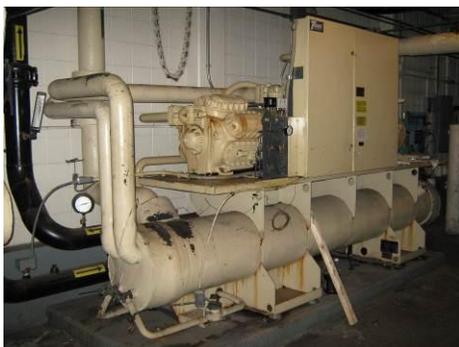
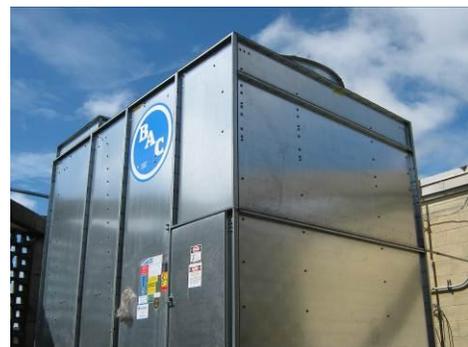
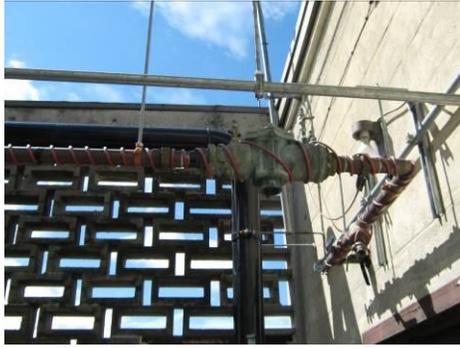
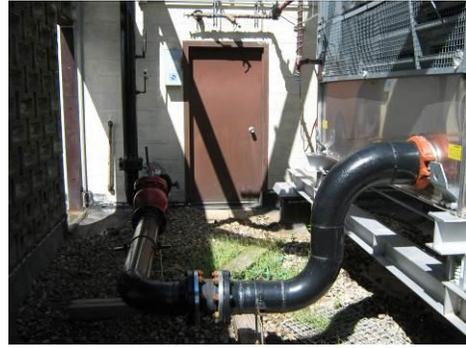
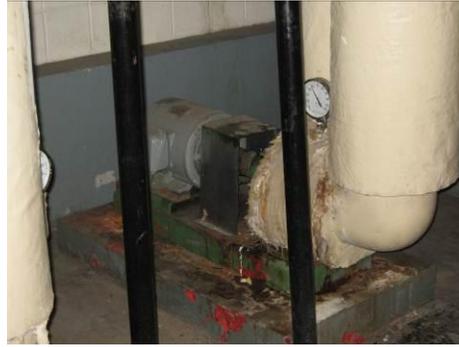
4. The air conditioning system consists of a Trane Model CCWBD181ECNPN80EGTCP electric chiller rated at 180 tons. The system also includes a roof mounted cooling tower manufactured by Baltimore Air Coil, chilled water pumps, piping, chilled water coils in the 4<sup>th</sup> floor air handling equipment, and controls. The chiller, chilled water pumps, piping, and chilled water coils are in poor condition. The cooling tower was replaced in the past two years and is in very good condition, however, the piping on the exterior of the building needs to be insulated.

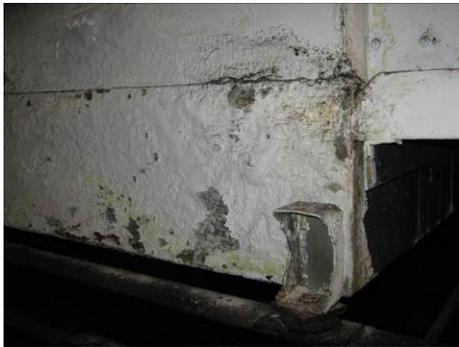
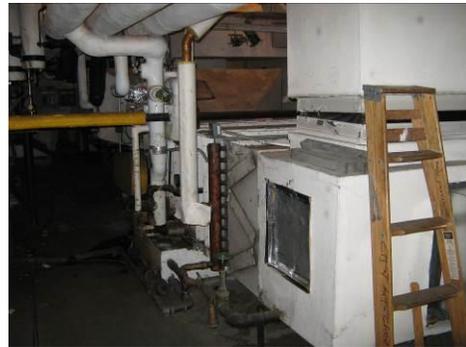
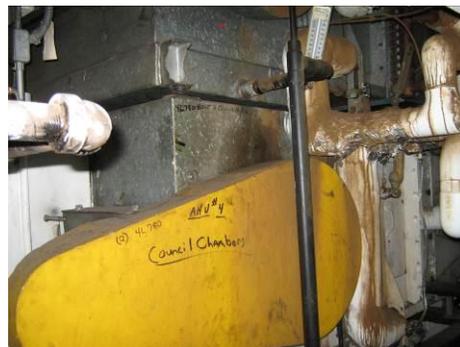
5. The air handling equipment is located in the 4<sup>th</sup> floor mechanical room. This equipment includes (4) air handling units with steam and chilled water coils, return air fans, miscellaneous exhaust fans, ductwork, piping and controls. With the exception of the new control system, all of this equipment is original to the facility and in very poor condition.

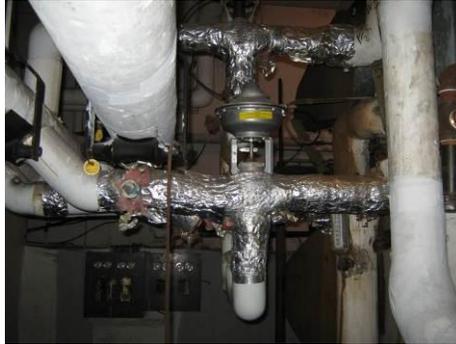
6. The steam piping consists of iron supply and condensate return piping. Some of this piping in the 4<sup>th</sup> floor mechanical room is missing insulation or the insulation has failed and replaced.

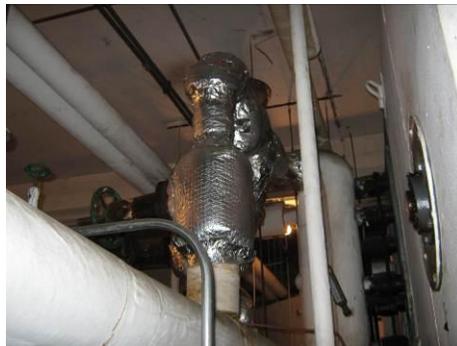
7. The chilled water piping consists of iron and copper piping. The condition of this piping is suspect as the chilled water treatment system has not been present for the entire life of the system. Some of the pipe insulation is missing or has been replaced where failures have occurred.

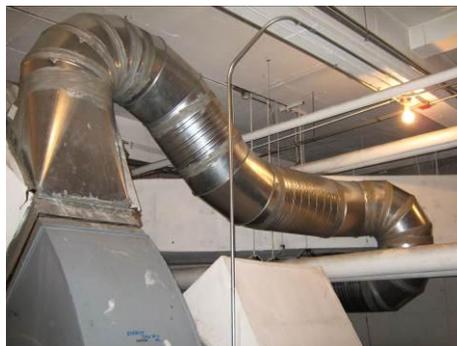
8. The air handling equipment distributes heated or cooled air to various locations in the building. AHU-1 serves the majority of the building. There has been some work done to add ductwork between AHU-1 and Return Air Fan 1 so that AHU-1 does not need to bring in 100% outside air all of the time. All of the air handling systems should be reviewed for ventilation rates and replaced with units with energy recovery capability.

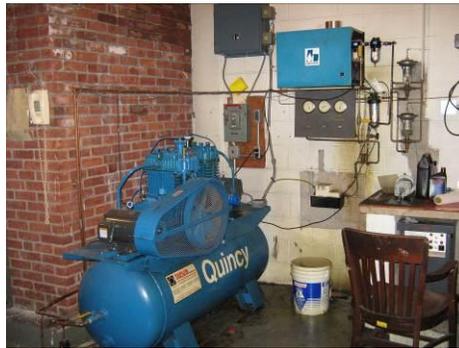
9. The exhaust fans located in the 4<sup>th</sup> floor mechanical room or on the roof serve toilet rooms, etc. This equipment is in poor condition.
10. The existing temperature control system consists of both electronic and pneumatic equipment. The head end is an Invensys DDC control system with the existing valves being pneumatic. There is an air compressor and air dryer located in the 4<sup>th</sup> floor mechanical room that services the pneumatic components. There is an excessive amount of condensation being removed by the air dryer so a bucket is located under the equipment to collect the water.

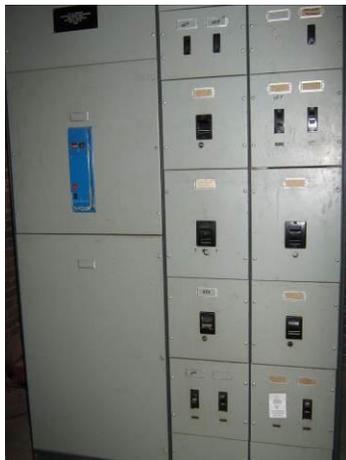
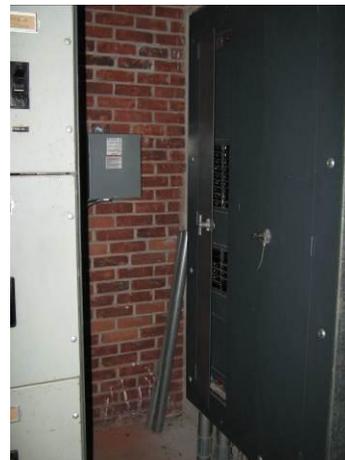
1. The building is served by a single electrical service rated 1600amperes, 480Y/277volts, 3-phase, 4-wire. This service equipment consists of a 1600amp main disconnect switch, distribution sections and metering per utility company requirements. The service equipment is original to the building and is in fair condition. There is an electrical panel located adjacent to the main electrical switchboard where the required clearance between the front of the panel and the switchboard does not meet code requirements. In addition, the current electrical room access does not meet the current code requirements for egress from the room.

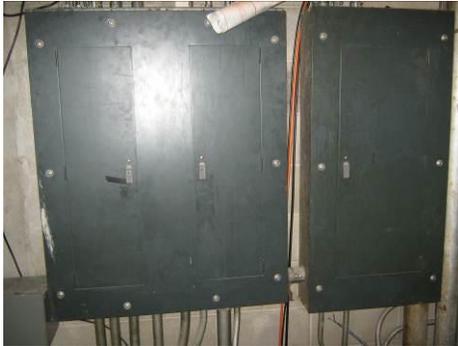
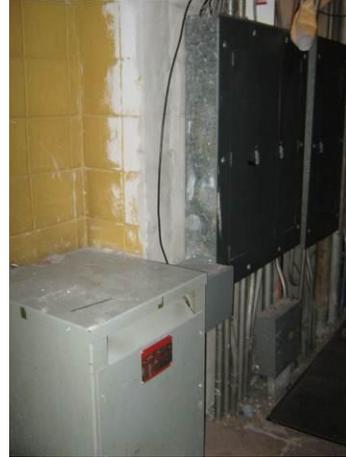
2. There are a number of electrical panels located throughout the facility. These panelboards are original to the facility. The condition of these panelboards is fair. The majority of the panelboards do not have spare circuit breakers available for new circuits to be added, or have space to add new circuit breakers.

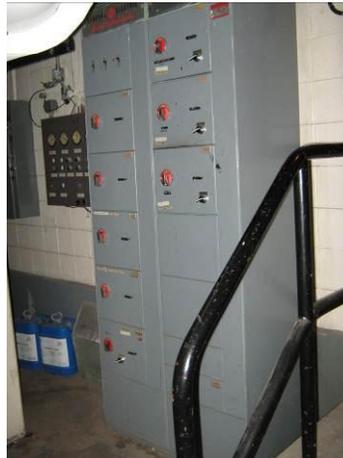
3. There is a motor control center located in the boiler room to serve the mechanical equipment in the boiler room. This equipment is original to the building and in fair condition. The required clearance in front or on top of this equipment does not appear to meet current code requirements.

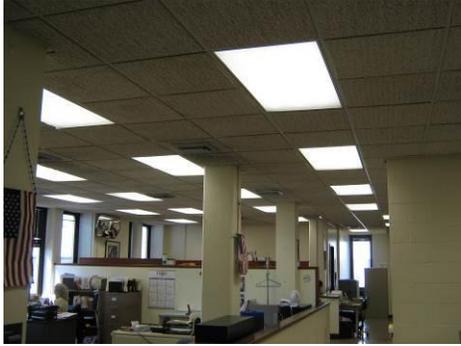
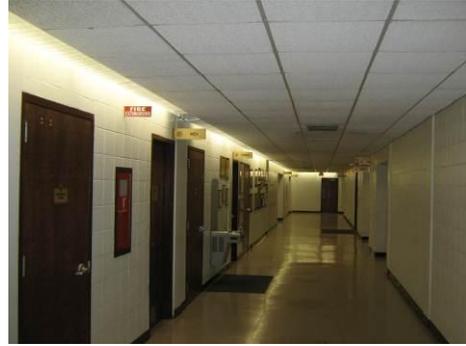
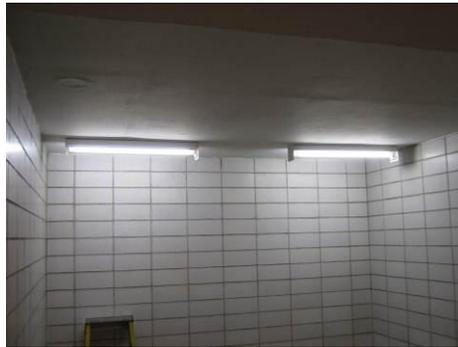
4. The lighting throughout the facility consists primarily of recessed mounted acrylic lensed fluorescent fixtures in the office areas, toilet rooms, etc. A recessed fluorescent cove lighting system is located in the corridors. Industrial fluorescent fixtures are located in storage rooms. There are other miscellaneous fixtures spotted throughout the building. Most of the lighting has been upgraded to newer T8 technology, however, there are other fixtures using older T12 technology or incandescent lamps. The lighting ranges from good to poor condition.

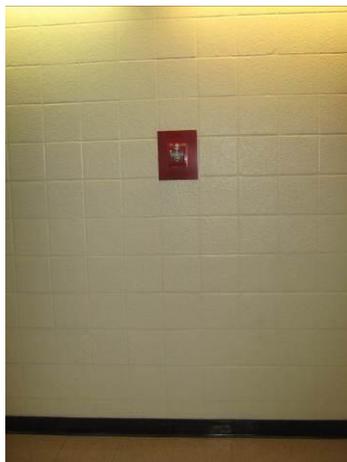
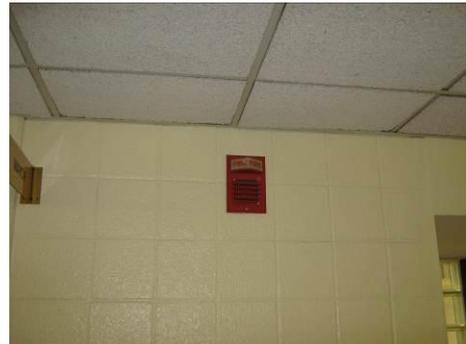
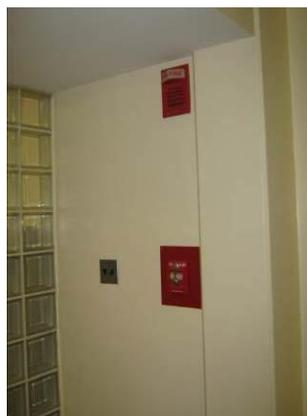
5. The fire alarm system is manufactured by Simplex. The system includes manual pull stations, horn strobes, and ceiling mounted heat detectors. This system is in fair condition and non-ADA compliant. Smoke detectors and additional audio visual devices should be added to the building.

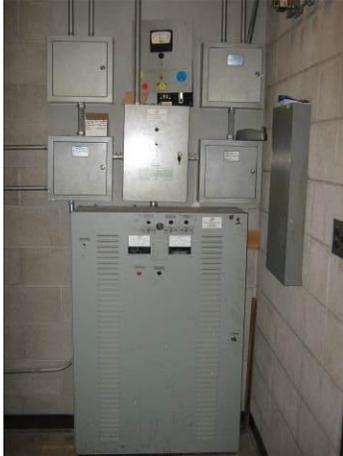
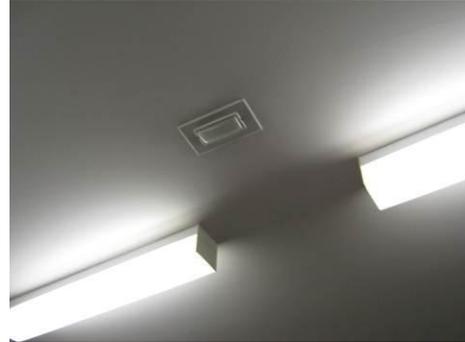
6. The emergency lighting is provided by a Dual Lite Inverter System that includes the inverter, batteries, ceiling mounted remote heads and controls. Although this system is operational, it is in poor condition. Additional lighting fixtures are required to meet current requirements for emergency lighting.
